(9A) Configuration Fault Code on Dolly & Trailer Panels

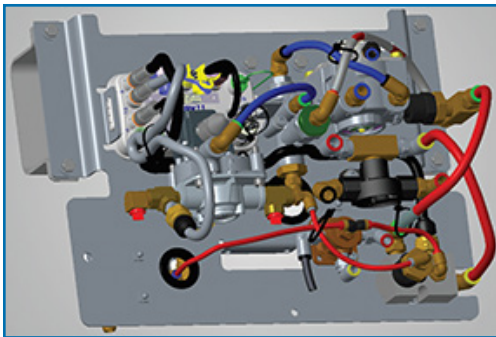
Dolly Panel Part Number: N-4299-BS

A 9A Fault Code will be generated when the ITCM ABS powers up with < 8.0 Volts on permanent or stoplight power only. See L31286 page 33 (available on haldex.com). This generates an active configuration error that does not affect the ABS lamp or ABS performance.

1. The condition of the 7-way cable wiring (oxidation, corrosion, etc.) will cause voltage drops.
2. The condition of the 7-way can cause intermittent connections due to loose or worn connectors, pins and receptacles on either tractor or trailer.
3. The condition of the ABS power cable & connector (oxidation, corrosion, loose or worn pins). All conductors and connections should be clean, bright and tight.
4. Voltage drops due to causes 1 - 3 above using double and triple trailer combinations causes even larger voltage drops. The longer the trailer(s) combination and the more 7-way connections used the higher the voltage drop or loss of voltage to the ECU.

Do not remove the ECU from the panel because this fault code is caused by powering up with < 8.0 Volts. The fault code can be cleared from memory after repowering with > 8.0 Volts using any Haldex diagnostic tool.
