Product affected  
EB+ Gen3

S/B No  
0003W

Title / Subject  
Gen 3 Leak Test

## How to determine the source of leakage on Gen 3 (\*)

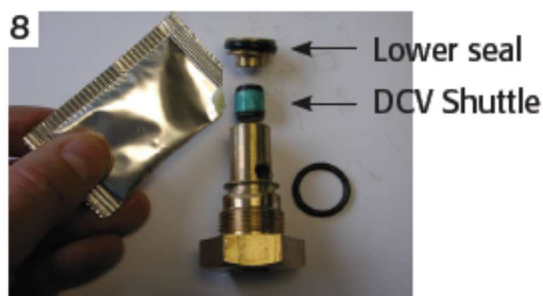
The DCV should be removed and shuttle examined for any signs of damage and replaced if required, it may be worth replacing the shuttle just to eliminate it as sometimes it is difficult to identify any visible damage.

950 800 307      Gen2/Gen 3 QRV service kit.  
950 800 905      Gen2/Gen 3 DCV service kit.

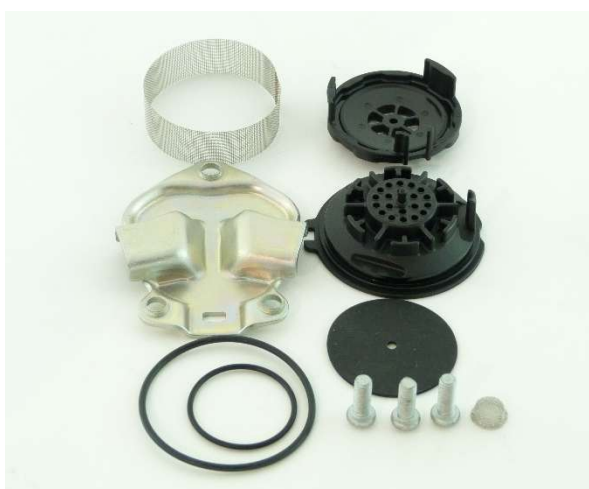
If the valve continues to leak, then pull the park brake and remove the QRV from the bottom of the valve.

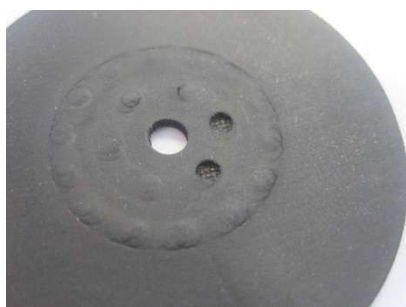
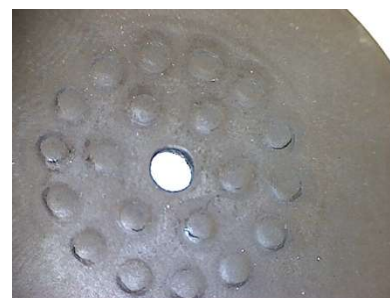
## Some examples of damaged diaphragms

Examine the rubber diaphragm for any signs of damage or contamination and replace if required. Once diaphragm has been inspected / replaced then push in the park valve and check for leaks. If there is no leak, then re pipe chambers and check again.
