Haldex Remanufactured Brake Shoes

The Standard of Quality

Are You Getting Cores That Make the Grade?

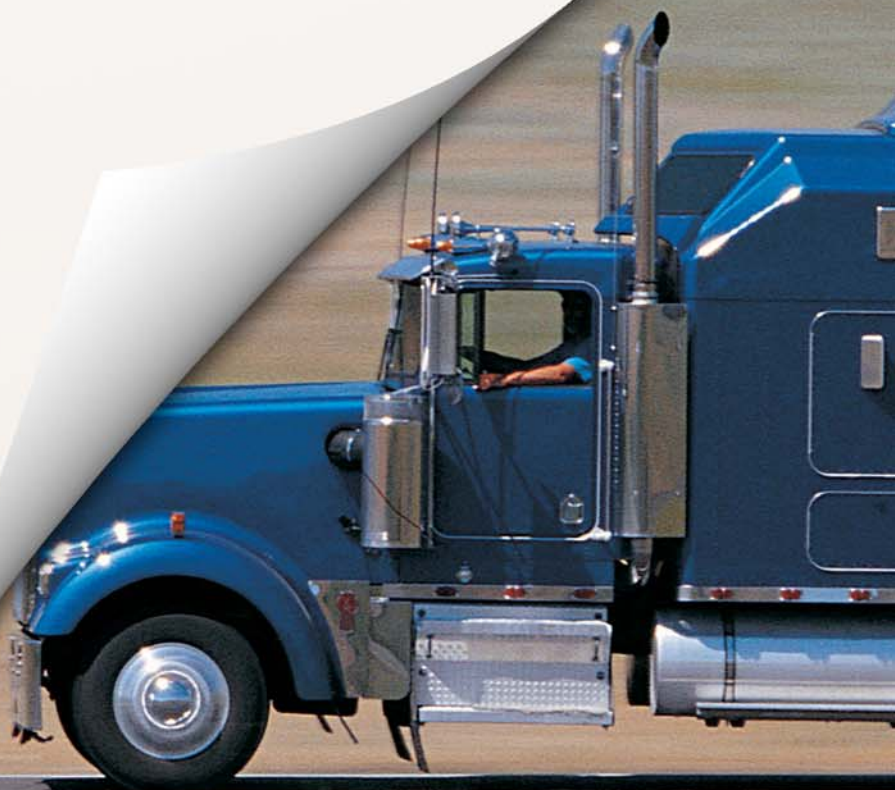
This is precisely why the quality legacy at Haldex begins with a critical selection process for brake shoe cores. Haldex “grades” EVERY core that we touch – and you only get the one’s rated at the top of the class.

Cores with quality grades of 1, 2 or 3 are initially deemed acceptable to continue through the remanufacturing process. These cores will exhibit tables that are in excellent condition. They would not have been exposed to excessive corrosion or other damage. Rivet holes are symmetrical.

Cores with quality grades of 4, 5 or 6 are automatically culled from the production process and scrapped. These cores exhibit characteristics that will shorten the life cycle of the shoe and have a high potential to prematurely corrode. Rivet holes are often out of spec.

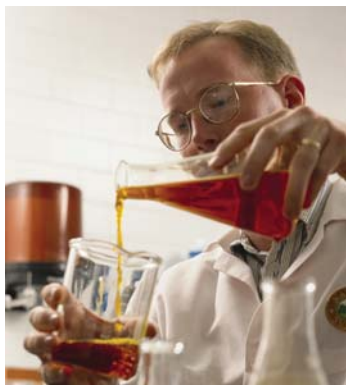
The Haldex corrosion protection solution is born out of extensive research and development using several types of laboratories. These specialists carefully consider the environmental factors that brake shoes are exposed to. As a world class leader in manufacturing, Haldex understands addressing this type of condition extends far beyond applying a surface coating. Through careful analysis corrosive protection processes have been developed.

The characteristics of the coating itself are important, however, long term life cycle performance is derived from the systems surrounding the coating. Core preparation, the ability of the coating to adhere to the shoe and the curing process will determine the level of corrosion protection over the long-haul.

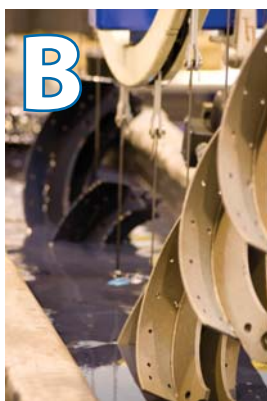
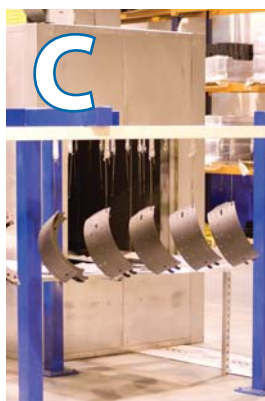
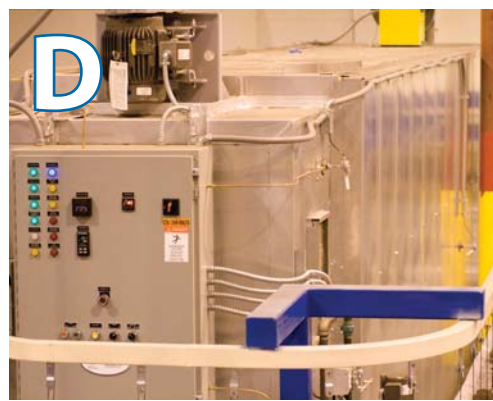
A. Shoes are individually shot-blasted and washed to ensure complete removal of contaminants and proper surface preparation for superior coating adhesion.

B. Haldex utilizes a "full dip", complete submersion process to ensure that coverage is uniform. Paint viscosity is checked several times daily to maintain critical tolerances.

C. Dwell times during the curing process are carefully adhered to before and after coated shoes enter the curing booth. This is another area that must be critically maintained to ensure maximum protection.

D. Computer controlled curing booths are in operation at all Haldex Friction Centers. It is necessary to control factors such as humidity and temperature during the cure process, otherwise corrosion protection is severely limited.

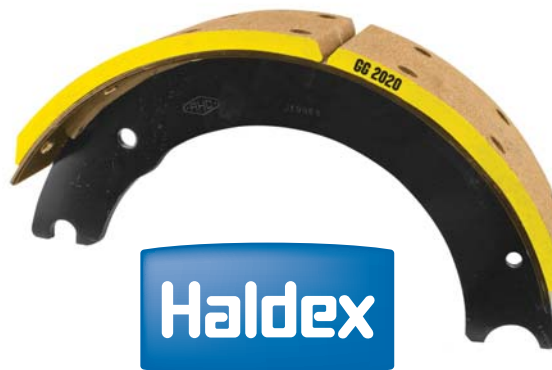
Corrosion Protection Comparison and Process Troubleshooting

Summary Analysis: Little corrosion present at any cycle interval

Summary Analysis: Little corrosion present between cycles 1 and 4. This indicates that paint cure was accomplished fairly well. Corrosion explodes between cycles 4 and 10. This indicates that the paint breaks down fairly quickly as it endures the elements of each cycle.

Summary Analysis: Corrosion present after just one cycle of testing. This indicates that the cure process is substandard. Corrosion remains consistent between cycles 1 and 4. This indicates the paint is somewhat stable at these early stages. Corrosion explodes between cycles 4 and 10. This indicates that the paint destabilized pervasively during this period.

Cycle test conducted at Assured Testing Services, an independent A2LA accredited laboratory that specializes in corrosion simulation. Cycle tested per SAE J2334 criteria. Each 24 hour cycle includes temperature variants, salt/chemical application 100% humidity and arid environments.

Haldex employs several methods in which we continuously verify the performance level of the corrosion protection processes. Primary laboratory test specifications utilized include ASTM 117B salt spray testing as well as SAE J2334, which simulates the variable elements of our environment over "24 hour cycles". These tests are conducted at our own testing facilities as well as certified independent agencies and on trucks and trailers on your roads, logging thousands of test hours everyday.
